# Sky View window

Important operational safety advice relating to your Swift Fiat Motorhome Sky View Window.

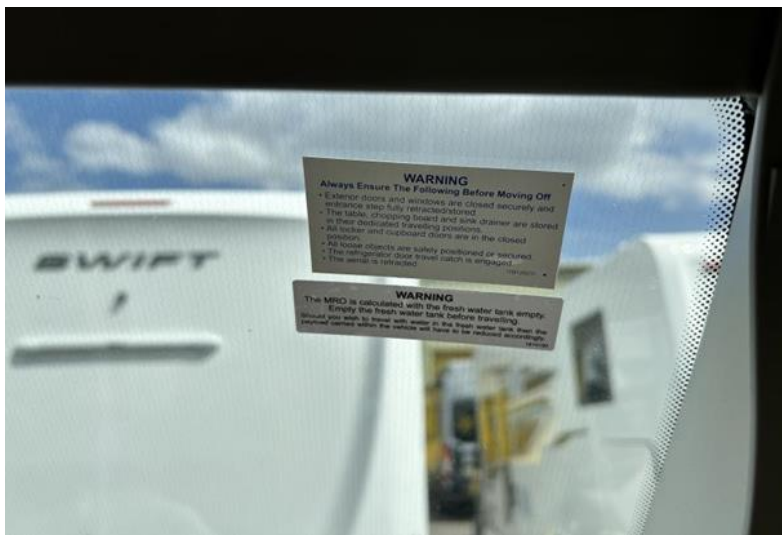
This has been advised in the user handbook and also using advice labels on the cab windscreen. Example of the advice label is provided below.

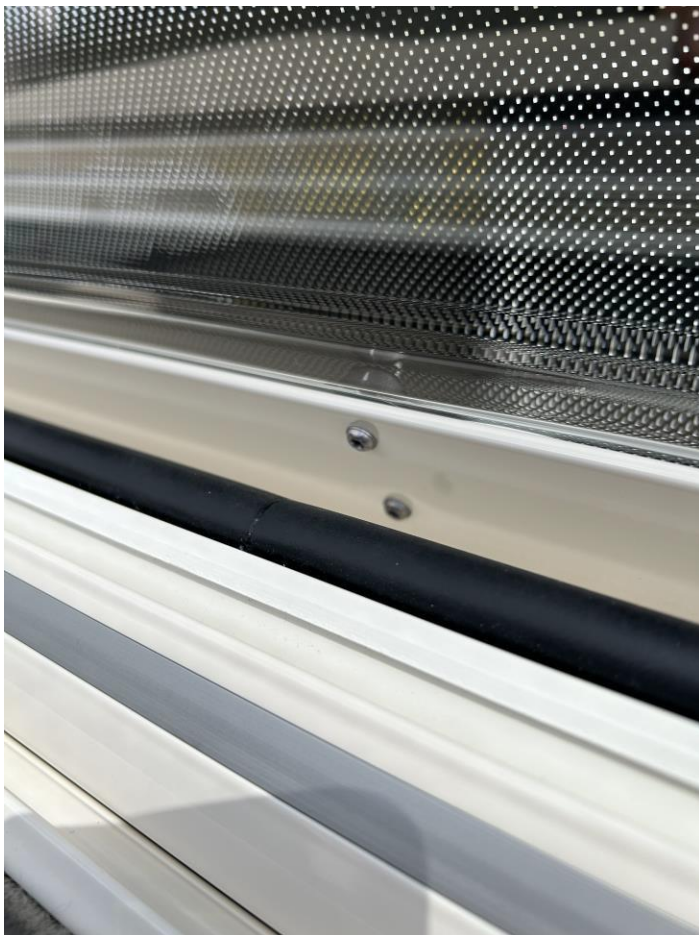
- 1) Unsecure the window catches
- 2) Open the window to the maximum position the mechanism will permit
- 3) Inspect the six screws are present on the lower window hinge profile and that they appear to be fully secured in place i.e. the base of the screw head is flat on the profile and no screw thread is visible under the head.

Figure 2 - Example of unsecured lower screw fixing with a loosened (lower) screw

If, upon inspection, screws are missing or in an unsecured state then please contact a Swift Approved workshop or any AWS approved workshop that can rectify this issue quickly with a Fixing Kit, please note this will be on a chargeable basis.
